MISSOURI - KANSAS CITY BASIN

LAKE SCHEFFBORG DAM
LAKE LUCERN DAM
LAKE INNSBROOK DAM
INNSBROOK DEVELOPMENT
WARREN COUNTY, MISSOURI

**PHASE 1 INSPECTION REPORT
NATIONAL DAM SAFETY PROGRAM**

OCTOBER 1980

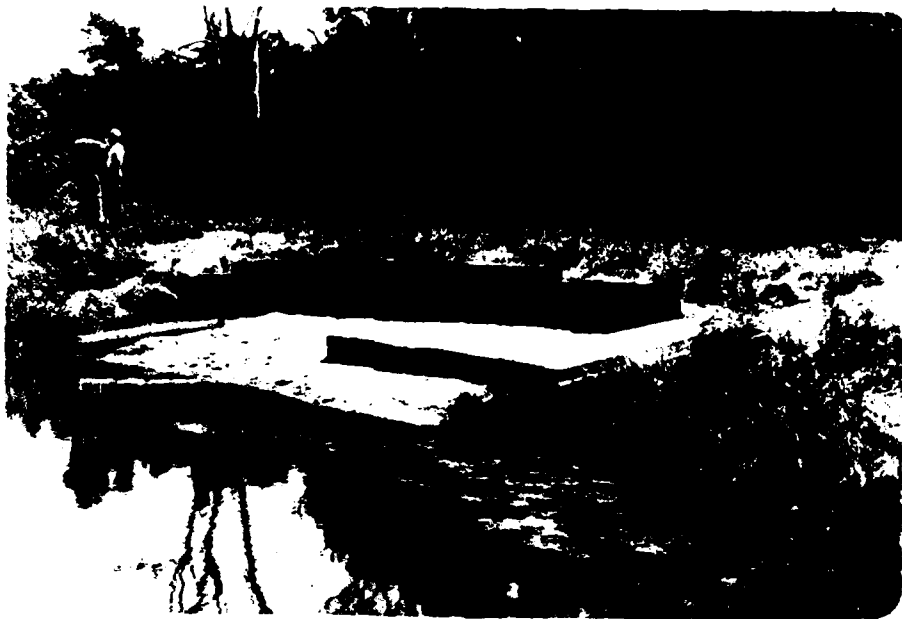
NO. 3: BEACH AREA NEAR RIGHT ABUTMENT

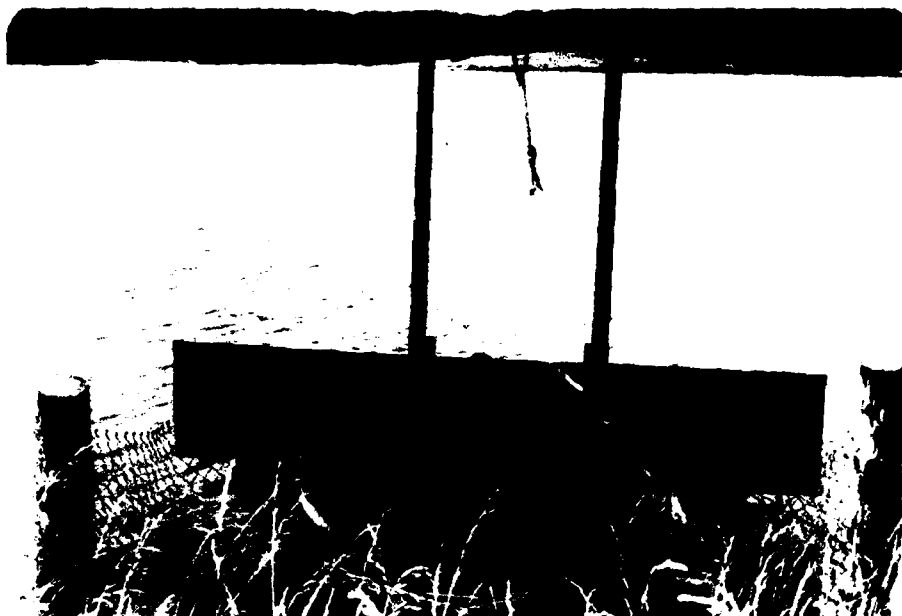
Inspection of the 5-foot diameter steel drop inlet spillway structure (see Photo 11) and its 30-inch diameter steel outlet pipe (see Photo 12) indicated the facility to be in satisfactory condition, although oxidation of the unprotected steel surfaces had caused a light coating of rust in most areas. The 28-inch wide by 36-inch high slide gate built into the upstream face of the inlet as well as the anti-vortex steel plate across the top of the inlet, also appeared, except for some minor corrosion of the steel surfaces, to be in good condition. However, the slide gate was not operated to test its performance.

NO. 11: DROP INLET SPILLWAY

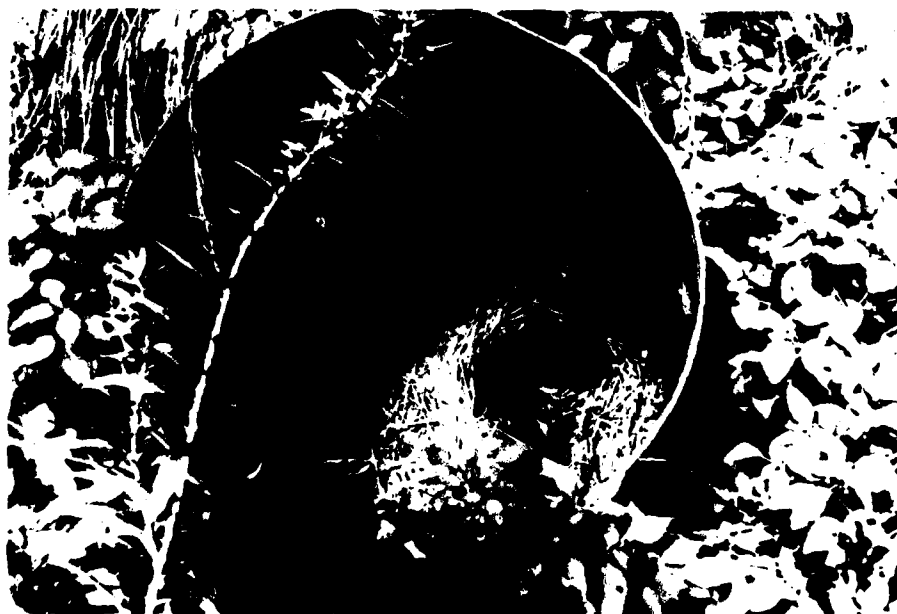
NO. 28: VALVE FOR LAKE DRAWDOWN PIPE

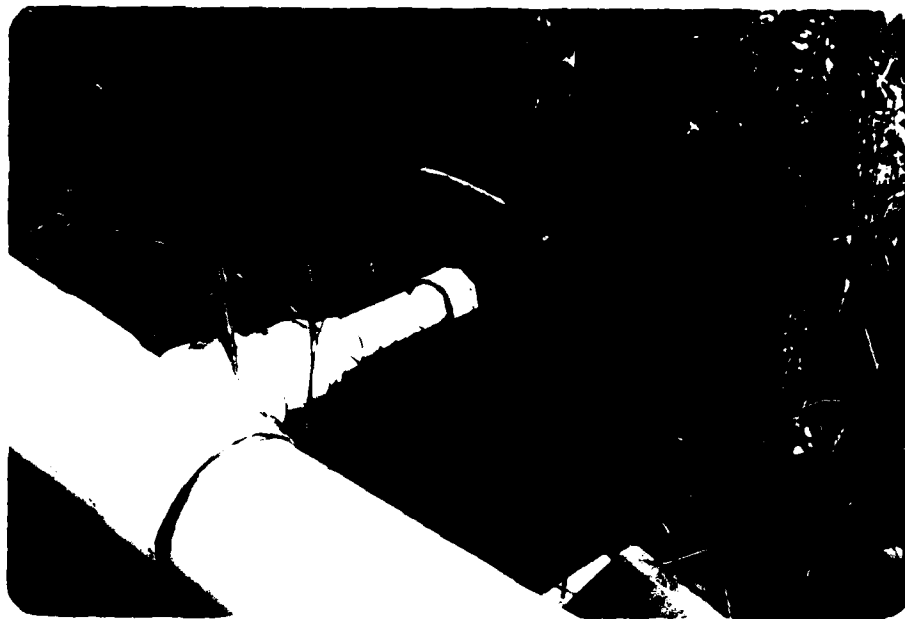
NO. 29: DRAIN VALVE FOR LAKE DRAWDOWN PIPING

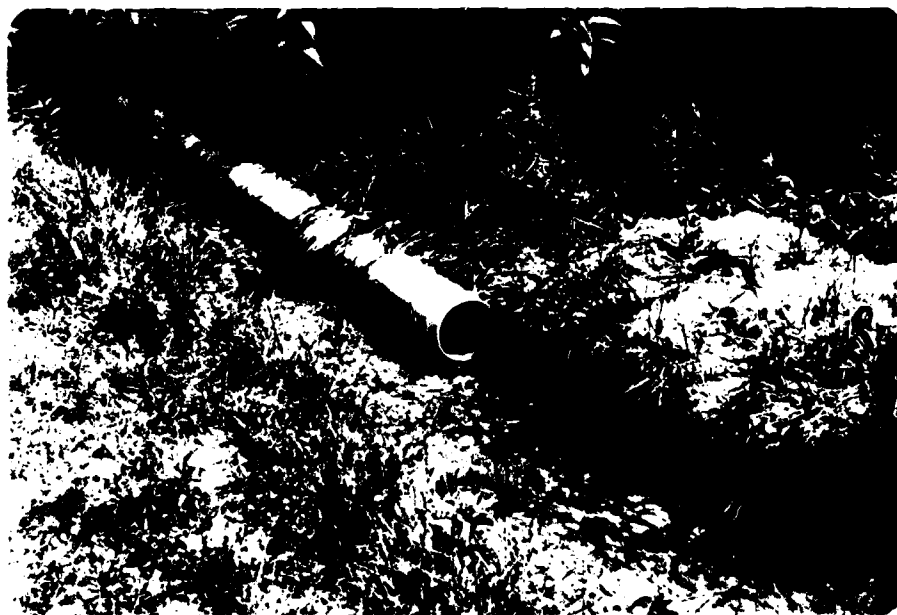
NO. 30: DOWNSTREAM END OF LAKE DRAWDOWN PIPE
